CUSTOMER XYZ REPAIR REPORT
ACTUATING LINEAR CYLINDER

JOB No:	200046	DATE:	05-05-2020
INSPECTED BY:	Corey / Mark		
DESCRIPTION:	CYLINDER ASSEMBLY, ACTUATING, LINEAR: HYDRAULIC: DIAMETER 80 X 56; STROKE 215MM; V8DC MAXIMUM OPERATING PRESSURE: 75 BAR		
FAULTS ON CYLINDER AS NOTED BY CUSTOMER XYZ:			
-Requires Overhaul

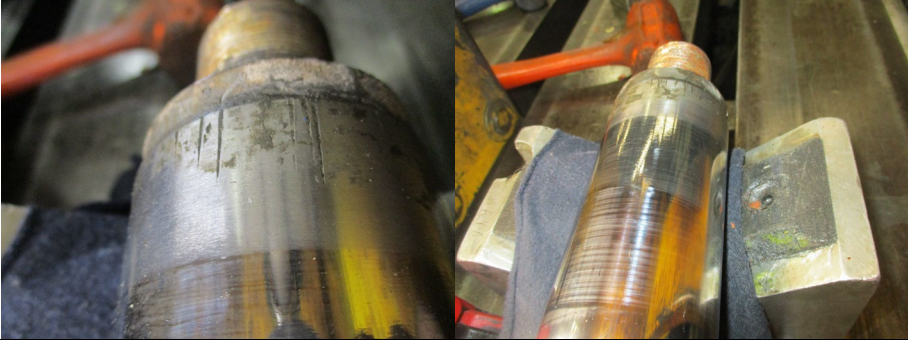
Qty	Part	Condition	Recommendations/Notations:	Photograph
1	Piston Rod	Replace	<p>There are multiple dents and scratches on the Piston Rod chromed surface.</p> <p>Piston rod will be replaced with a new one made from induction hardened chrome bar.</p>

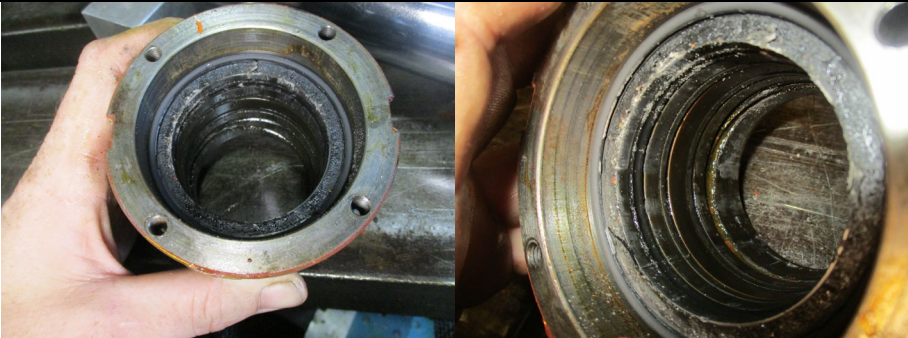
1	Head Cap	Reclaim	<p>The Head Cap needs rust treatment and polishing of the thread and sealing areas.</p> <p>It is worn on the inside diameter so it will also be modified to take a bush.</p>

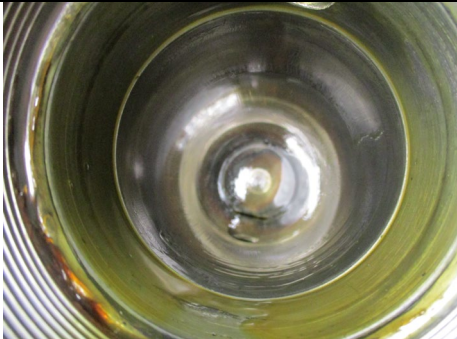
1	Barrel	Reclaim	<p>There are some light rust marks in the bore which will require honing to clean up.</p> <p>The thread needs a tidy up and the barrel will be reused.</p>

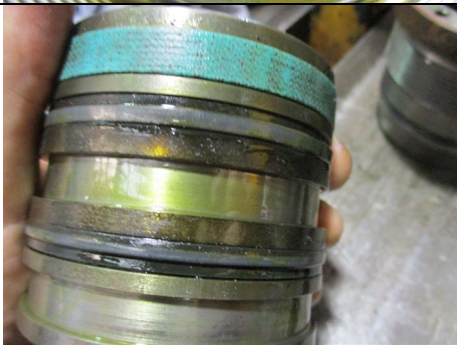
1	Piston	Reclaim	<p>Piston is in good condition.</p> <p>Light polish required for seal and wear ring grooves.</p>

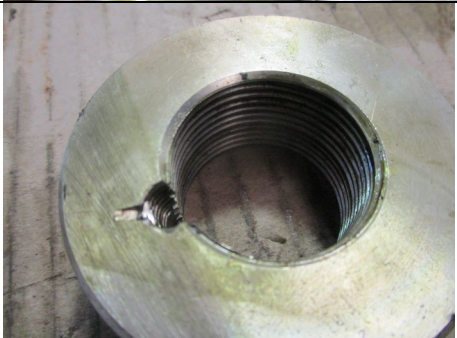
1	Piston Locknut	Replace	<p>The thread is damaged around where the scotch key was.</p> <p>A new Locknut will be made.</p>

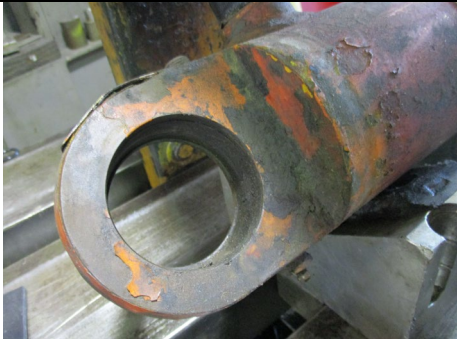
1	End Cap & Eye	Reclaim	<p>The End Cap and Eye need rust treatment in the bearing housing and a tidy up of some bruising around the edges.</p>

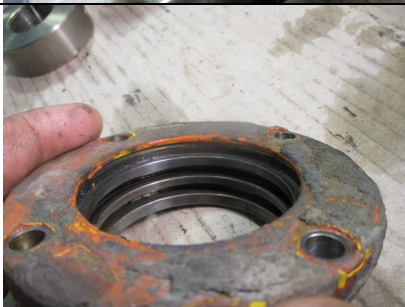
1	Front Gland	Replace	<p>The seal grooves measure oversize for standard seals. The wiper groove houses a soft poly urethane rod wiper which has allowed the ingress of dust and grit. A new Front Gland will be made to suit standard seals and to take a nylon rod scraper.</p>

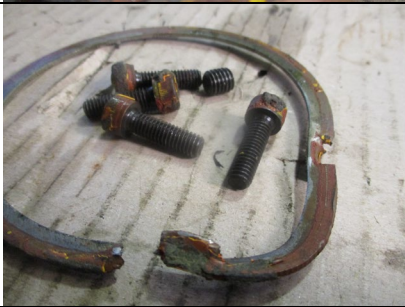
1	Locking Ring and Fasteners	Replace	<p>Existing Locking Ring is broken. This will be replaced with a new one.</p> <p>The four (4) Socket Head Cap Screws are worn and rusty and will be replaced.</p>

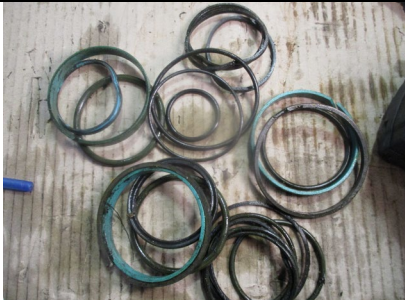
1	Seals	Replace	<p>All Seals will be replaced.</p>

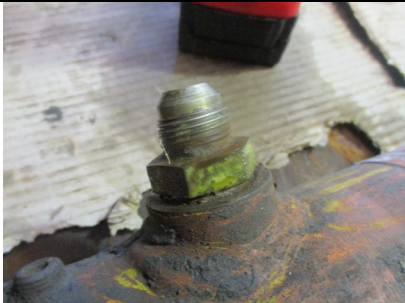
2	Fittings	Replace	The Fittings have rust on their threads and wear on the JIC seat. The fittings will be replaced. The cylinder arrived with tape over the ports. JIC caps will be supplied for shipping and storage.
